Destabilization of Pedicle Screws and Migration of Connecting Rod into the Posterior Cranial Fossa in a Patient After Posterior Spondylosynthesis with a Screw System

I.V. Burova¹✉, E.A. Litvinenko¹, S.A. Kurilchik¹, M.M. Erovenko¹, A.N. Velichkin²

¹ Regional Clinical Hospital No. 2

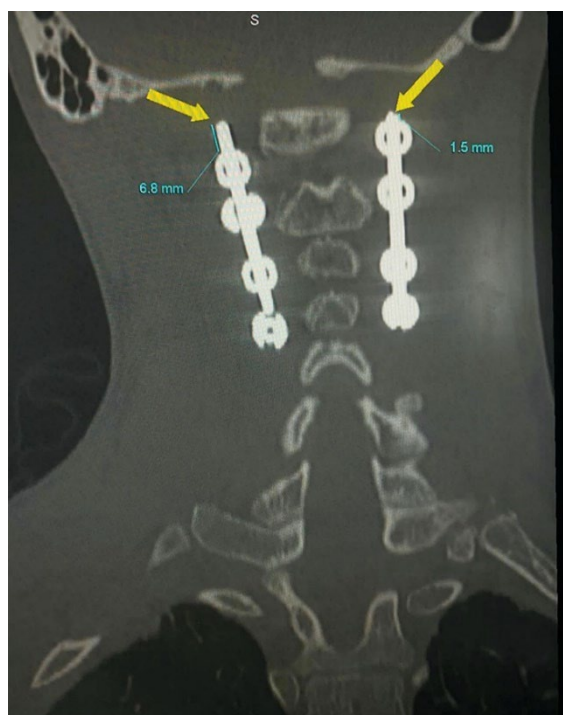
An objective method for determining the quality of installation of a transpedicular fixator is a series of dynamic CT studies in the late postoperative period [2]. According to the study of 16.04.2019, malposition of the first locking screw on the right was revealed, dislocation of the component part of the metal structure in the direction of the occipital bone up to 6.8 mm (Fig. 1). From the anamnesis, it was found that there were no complaints at this stage. A consultation with a neurosurgeon was suggested. He did not seek medical help.

Fig. 1. Computed tomography of the cervical spine with malposition of the first locking nut of the upper threaded screw on the right, dislocation of the component part of the metal structure in the direction of the occipital bone up to 6.8 mm

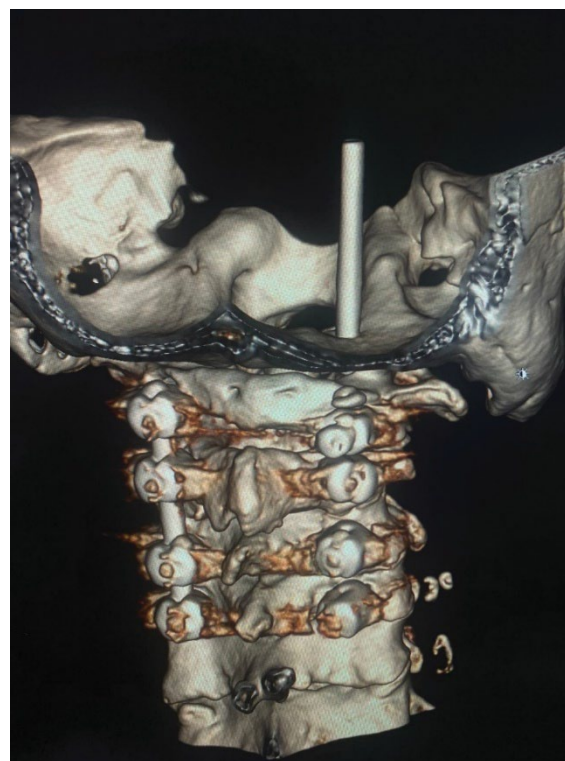
On 20.12.2022, the patient was examined on a routine basis. He noted a decrease in visual acuity, mainly during the daytime, and associated the deterioration of his condition with being in an upright position. According to the results obtained, during multispiral computed tomography, negative dynamics were determined in the form of destabilization of the pedicle screws and migration of the rod into the posterior cranial fossa, which spreads through the right hemisphere of the cerebellum, closely adjoining its tentorium (Fig. 2).

Fig. 2. Computed tomography of the cervical spine with migration of the rod into the posterior cranial fossa

As a result of the dislocation of a component of the metal structure, an abnormal opening appeared in the occipital bone due to its perforation 20 mm below the "nuchal" line and 14 mm to the right of the foramen magnum in the posterior cranial fossa.

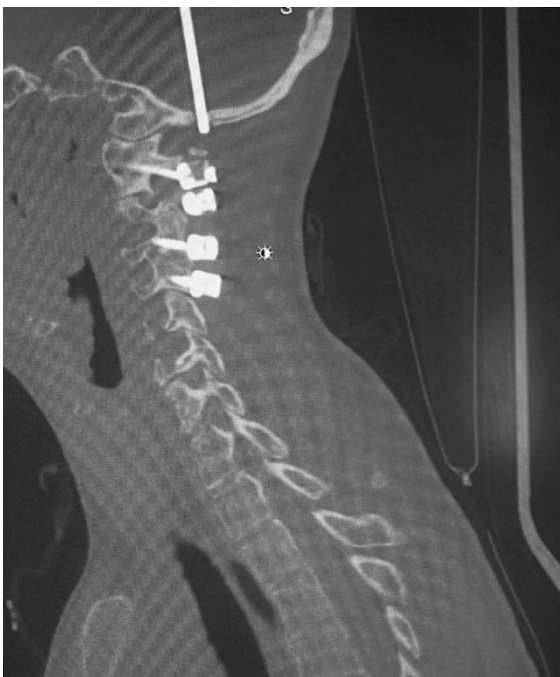
At the time of examination, a rod coming out of the screw heads was visualized in the lumen of the iatrogenic opening, and loosening of the threaded connections of the device was also noted (Fig. 3). The patient was recommended to consult a neurosurgeon.

Fig. 3. Computed tomography of the cervical spine with the rod coming out of the screw heads, as well as unscrewed threaded connections of the device

Migration of the endoprosthesis components is probably due to insufficient adaptation of the connecting rods to the slots of the screw heads, as well as the structural features of the MOS rod such as a streamlined shape and a small cross-section [3]. As a result of consolidated interaction between clinicians and diagnosticians, it was established that a decrease in visual acuity is most likely associated with transient ischemia of the medial surface of the occipital lobe due to an increase in the pressure of the rod while the patient is in an upright position [4, 5]. At the time of transition to the horizontal plane, the degree of compression decreases, but to confirm this hypothesis, a more detailed study of the structural relationship of the structures under study is required using magnetic resonance imaging [6]. It is worth noting that there are no data on "spontaneous" perforation of the occipital bone by MOS elements in the domestic scientific literature. In foreign sources, there are references to the possibility of migration of metal components into the posterior cranial fossa. Thus, in the article *"Migration of Metal Construct Components into the Posterior Cranial Fossa: A Rare Complication of Spinal*
